TS-AMD- 82048b
December 1982

AERIAL PHOTOGRAPHIC ANALYSIS OF HAZARDOUS WASTE STUDY SITES New Mexico and Texas

Region VI

E. V. Dabney
Environmental Programs
Lockheed Engineering and Management Services Company. Inc.
Las Vegas, Nevada 89114

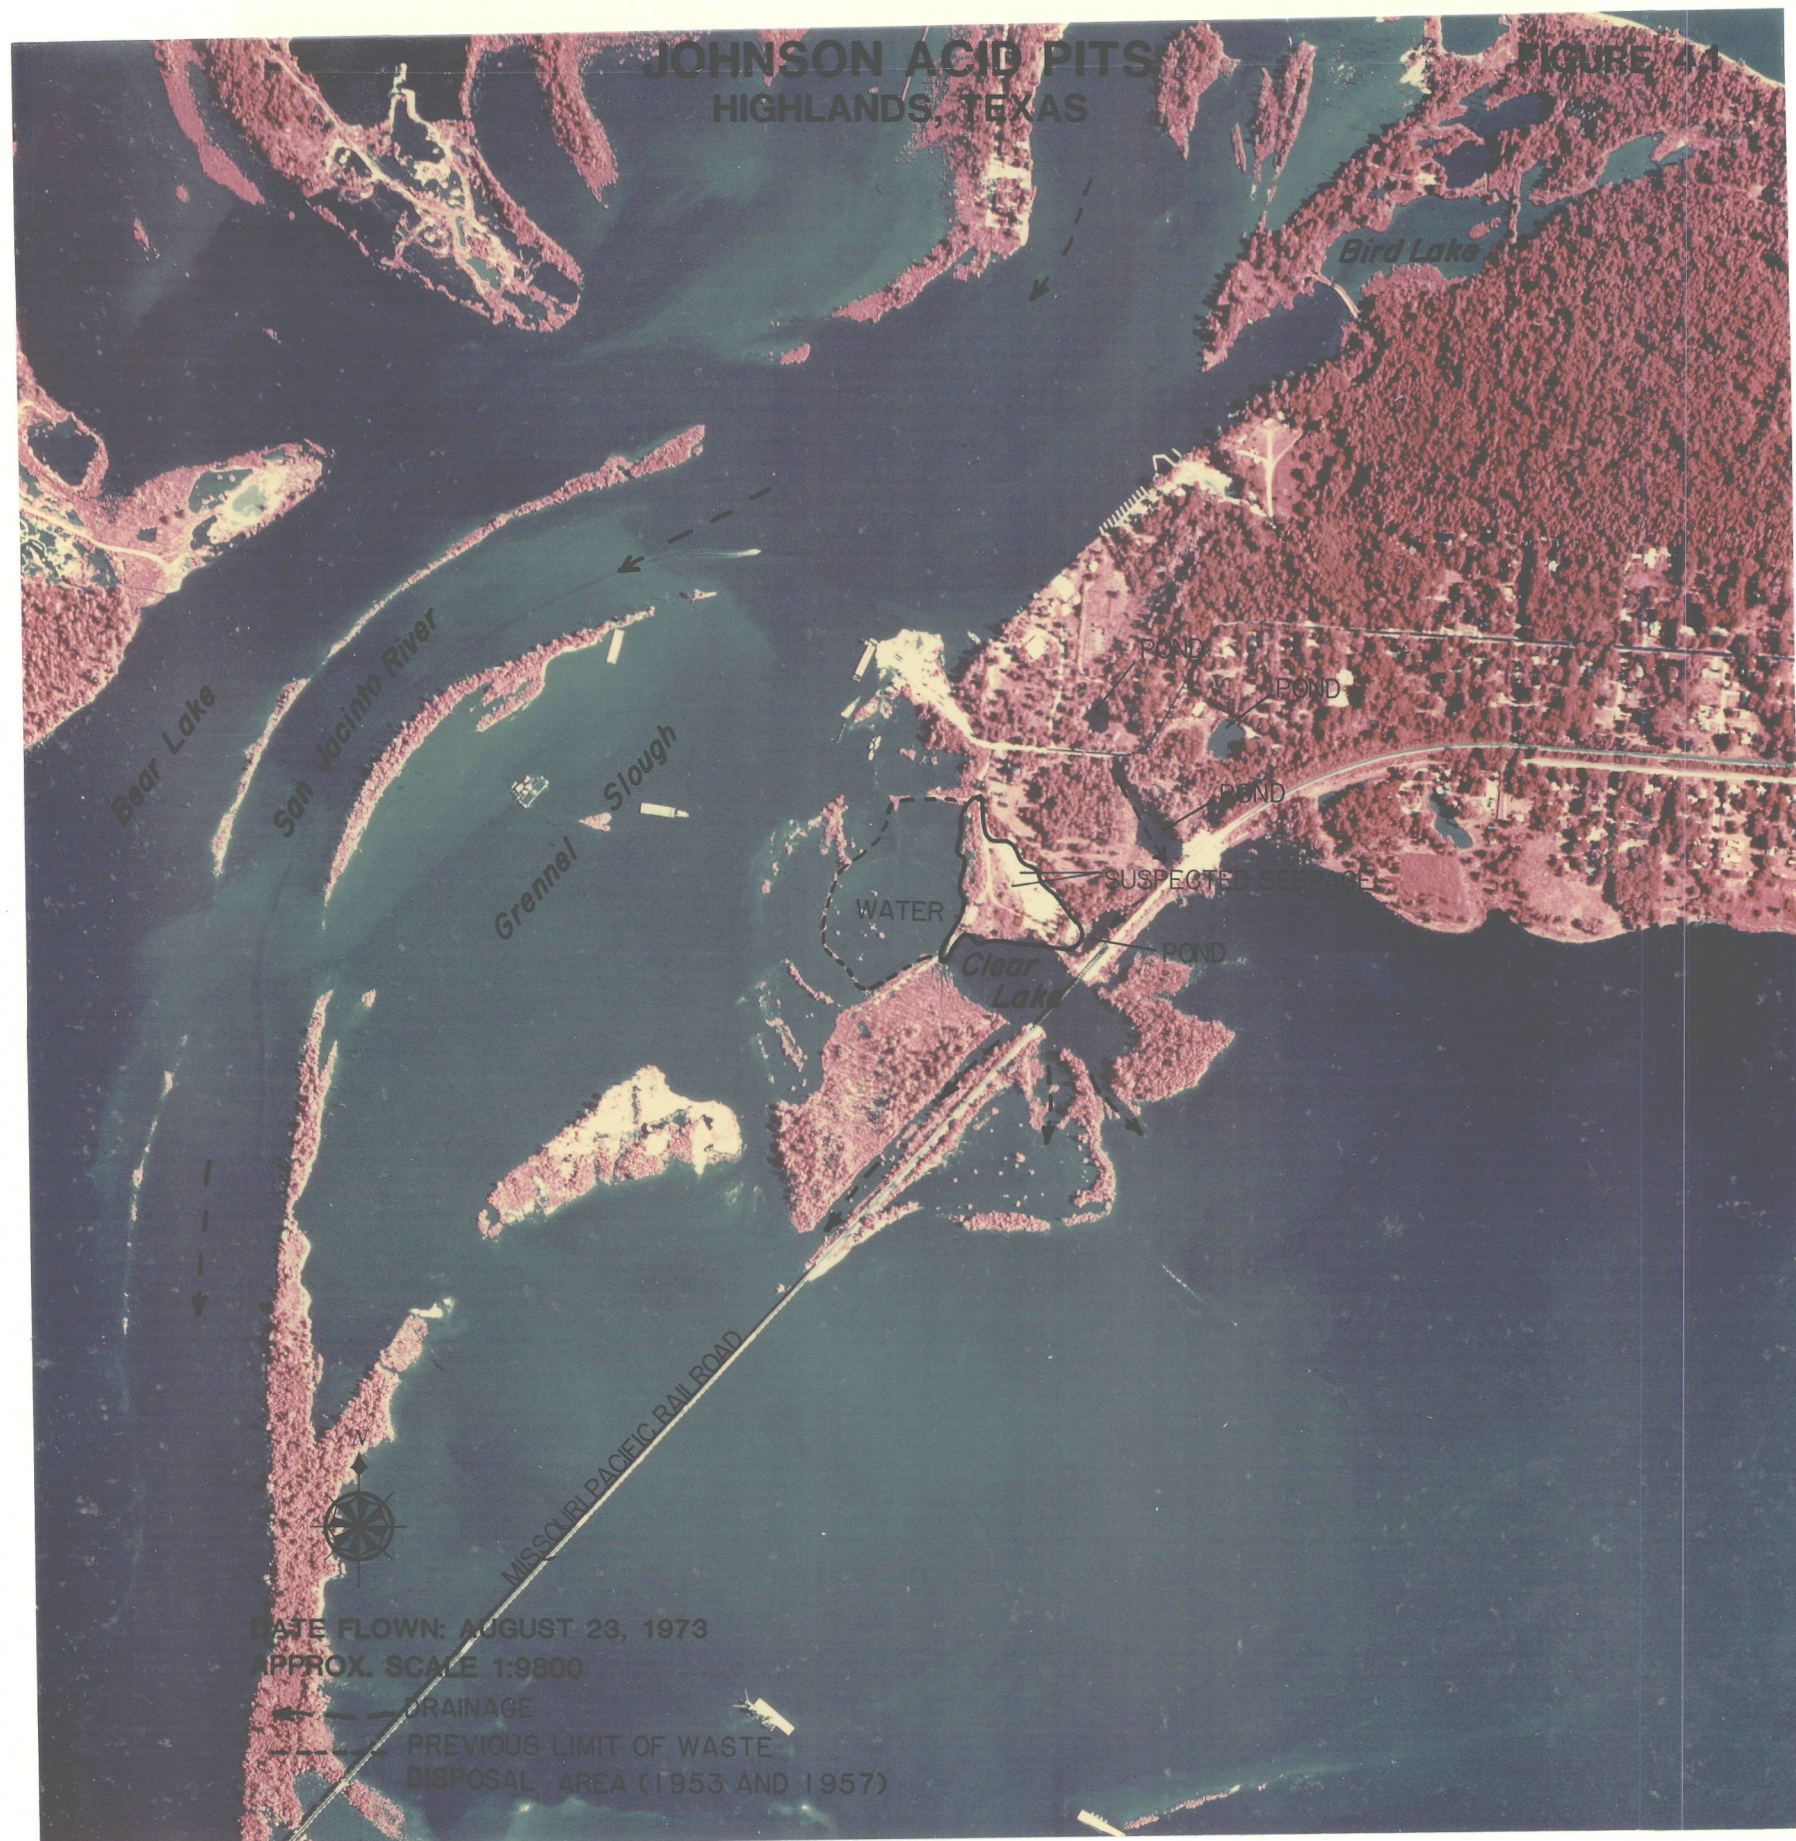
May 10, 1982, Photograph

Solid wastes and old tree limbs have been dumped within the disposal site (Figure 42). Three shallow pits are also present. Rainwater has collected in several site depressions, creating small ponds. Much of this standing water is highly discolored. There is no indication that the liquid has entered larger bodies of water that abut the site. Some dead vegetation is visible within the site.

An area east of the disposal site is inundated with water. This water has not reached the level of the disposal site. A dredge and several construction vehicles are operating within the flooded area.
